# Tidal Marsh Experiments and Restoration at Steedman Woods Reserve in York, Maine

Final report to:  
Old York Historical Society  
207 York Street,  
York, Maine

August 31, 2017

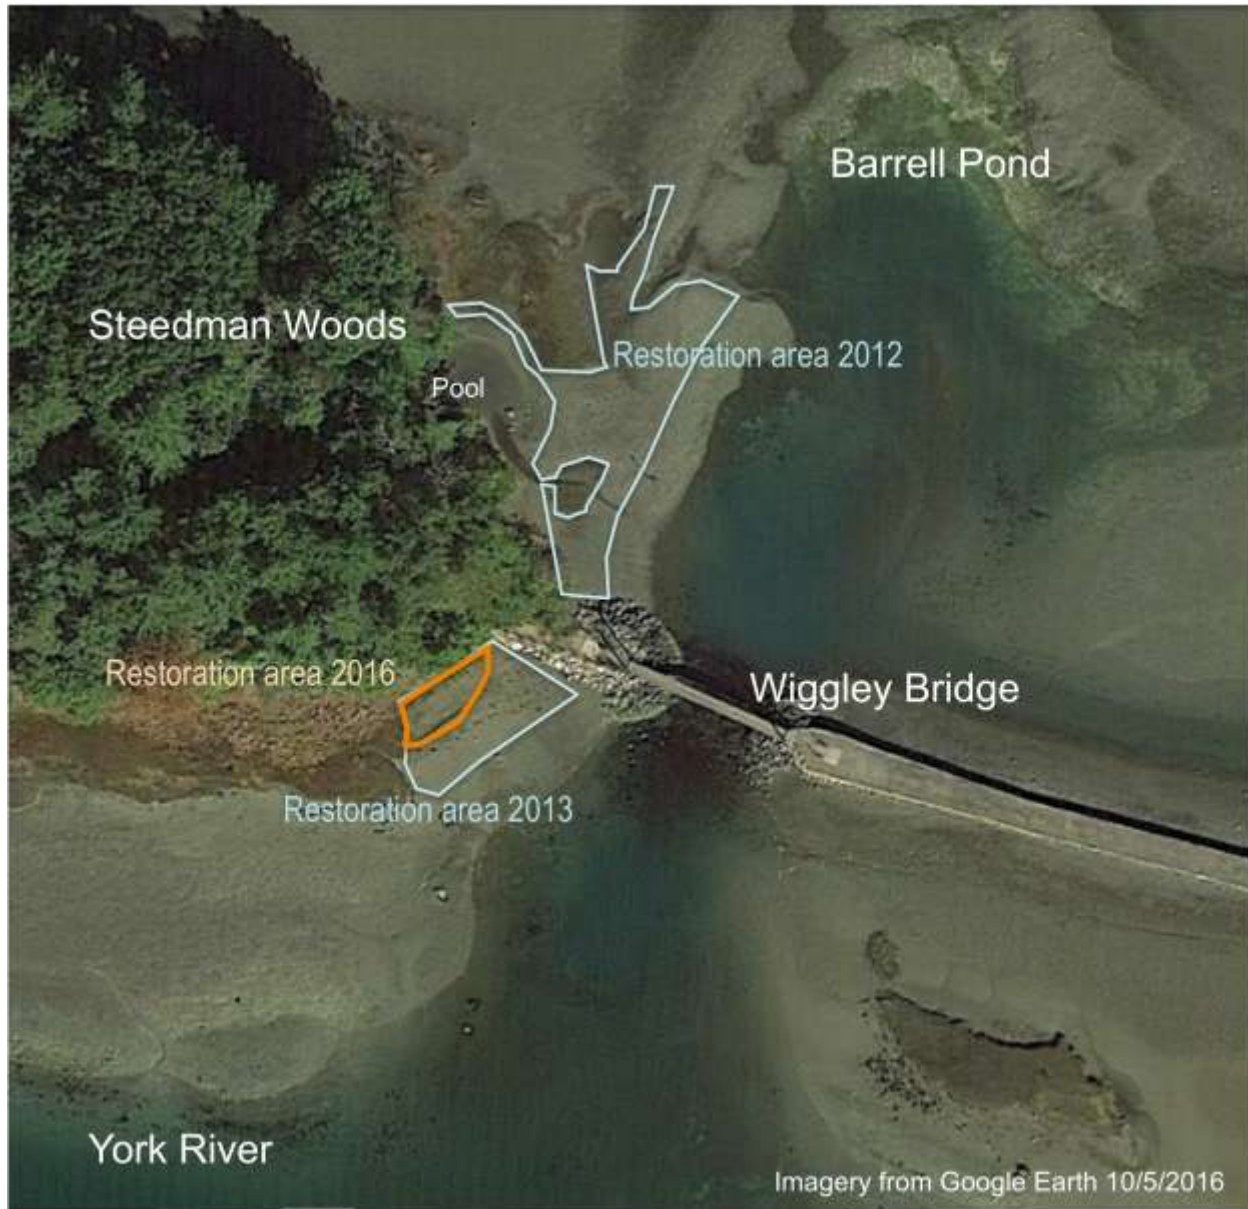
**Figure 1.** Restoration sites at Steedman Woods along Barrell Pond and York River shorelines. Restoration efforts in 2012, 2013 and 2016 are color coded by area. Cage experiments to examine snail impacts to plants were conducted in 2013 and 2015 along the Barrell Pond shoreline and a fencing experiment was performed at York River shoreline in 2015.

South of the Wiggley Bridge (York River side) is a small tidally influenced area of shoreline, mostly devoid of marsh peat and containing no living vascular plants (Figure 1). Erosion from the York River is clearly evident, likely from daily boat traffic and storms. What little peat is found here is the remnant of marsh that has been eroded away. The sediments consist mainly of inorganic, sandy to gravely areas that are wetter at lower elevations and steadily dry out up gradient. The salinity of the floodwaters is near seawater concentration, around 30 ppt.

North of the Bridge (Barrell Pond side), the area is comprised mostly of barren inorganic sediments with small islands of marsh and unvegetated pools (Figure 1). The sediments of the barren areas vary from silt to cobble. The sediment surface is also littered with common periwinkle shells. Very little organic matter is found here except in the marsh areas and at the higher elevations where terrestrial soil has been eroded down slope. Islands of existing marsh growing on thin peat deposits are mostly populated by stunted smooth cordgrass (*Spartina alterniflora*), with macroalgae mixed in. Although no motorboat traffic occurs on the pond side, a strong current flowing under the bridge appears to contribute to erosion. Similar to the York River side, the salinity of the floodwaters is also around 30 ppt.

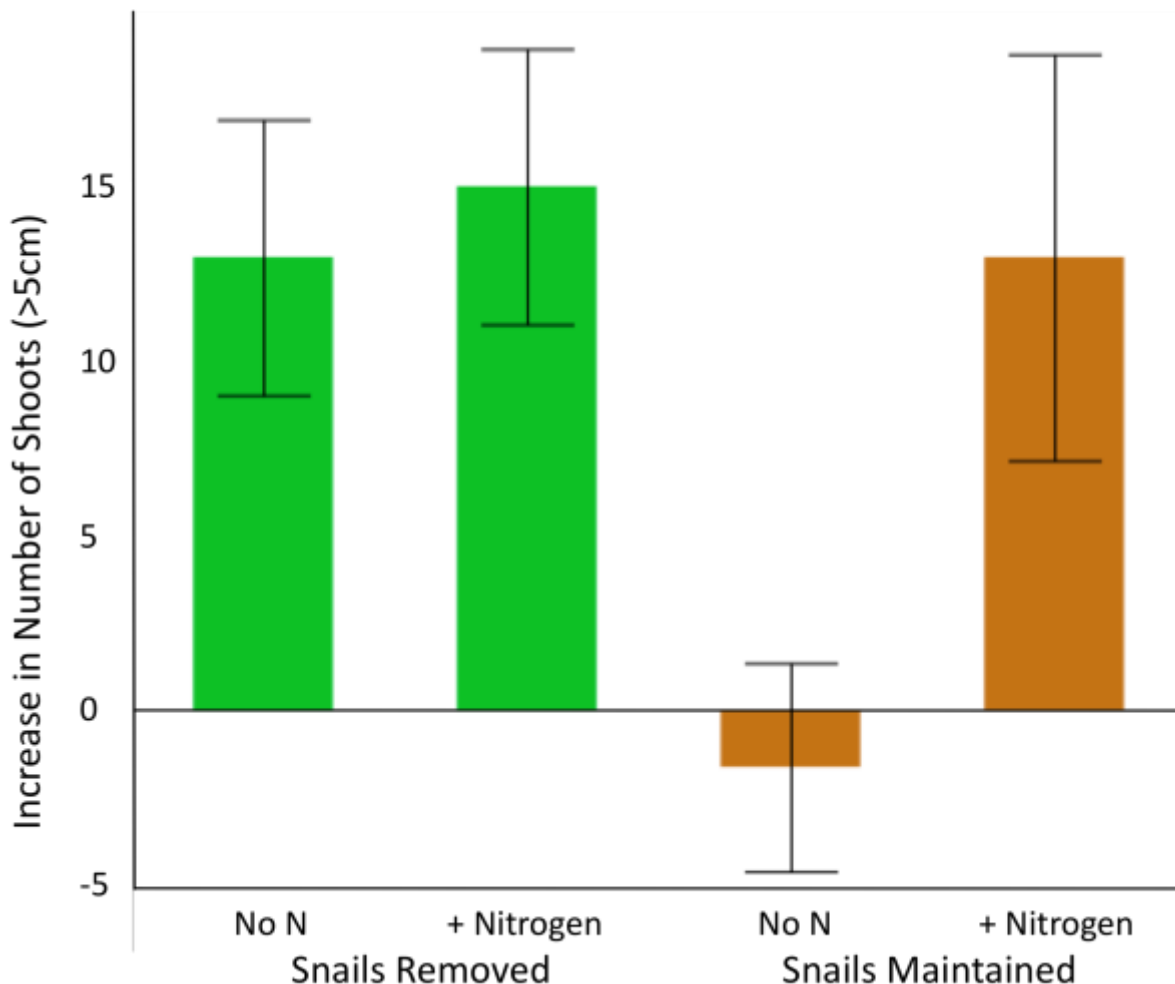
**Figure 3.** Expansion of existing salt marsh plants from existing salt marsh in cages with and without snails and with and without nitrogen fertilizer (n=5).

Twenty cages were placed along existing marsh edges and the number of shoots were counted before and after application of snail and nitrogen treatments. After 12 weeks, the number of shoots expanded in cages without snails (both with and without added nitrogen), but on average retreated in the cages with snails and without nitrogen fertilization (Figure 3). Surprisingly, when snail numbers were maintained in the cages and the plants fertilized, the number of new shoots was no different than without snails. The effects of: 1) snail exclusion; or 2) fertilization with snails allowed, both led to significantly greater numbers of shoots, important for habitat restoration efforts. In addition, the application of nitrogen fertilizer may have a beneficial effect on new shoot number, but the increase was not statistically significant in this experiment.

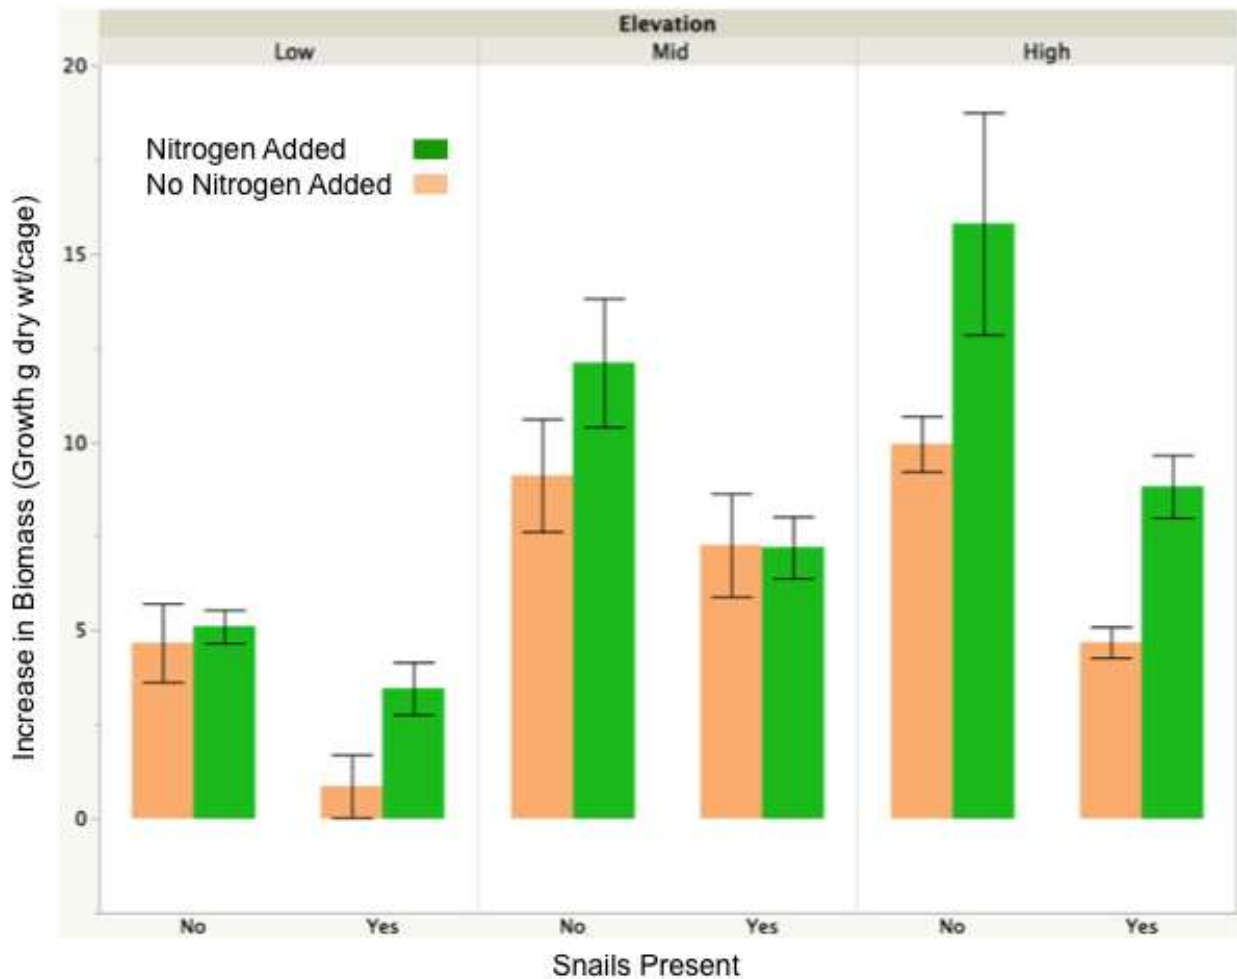
**Figure 4.** Change in biomass of *Spartina alterniflora* grown in cages with and without snails and with (green bars) and without (tan bars) added nitrogen at low, medium and high elevations. Means of 5 replicate cages (grams dry weight) are shown with standard error bars.

Twenty cages were placed at each of three elevations (high, middle and low) and one of four treatments manipulating nitrogen (N) and snails was assigned randomly to each cage: 1) No snails without N; 2) No snails with N; 3) Snails without N; and 4) Snails with N). Five groups of shoots were planted in each cage and snails and fertilizer were removed or added according to treatments specified in the Methods. After 12 weeks, the length and number of leaves of each shoot were counted. Applying a regression equation for each shoot, final biomass was predicted and the initial biomass of each cage was subtracted from the final to show biomass increase (growth). Statistical analysis using ANOVA showed significant effects from snails, fertilizer and elevation (Figure 4).

Snails added to cages resulted in 43% lower biomass growth in the plants; nitrogen addition led to 43% greater biomass increase; and lower elevation cages had 38% less growth than mid and high elevation cages. The interaction between Nitrogen addition and Snail presence was not significant (i.e., the effect of snails on growth was the same with or without nitrogen addition), nor were interactions between elevation and the two treatments. The mean biomass increases for each set of five replicate cages are graphed in Figure 4 to show both main effects (statistically significant) and interactive effects (not significant) found for this experiment.

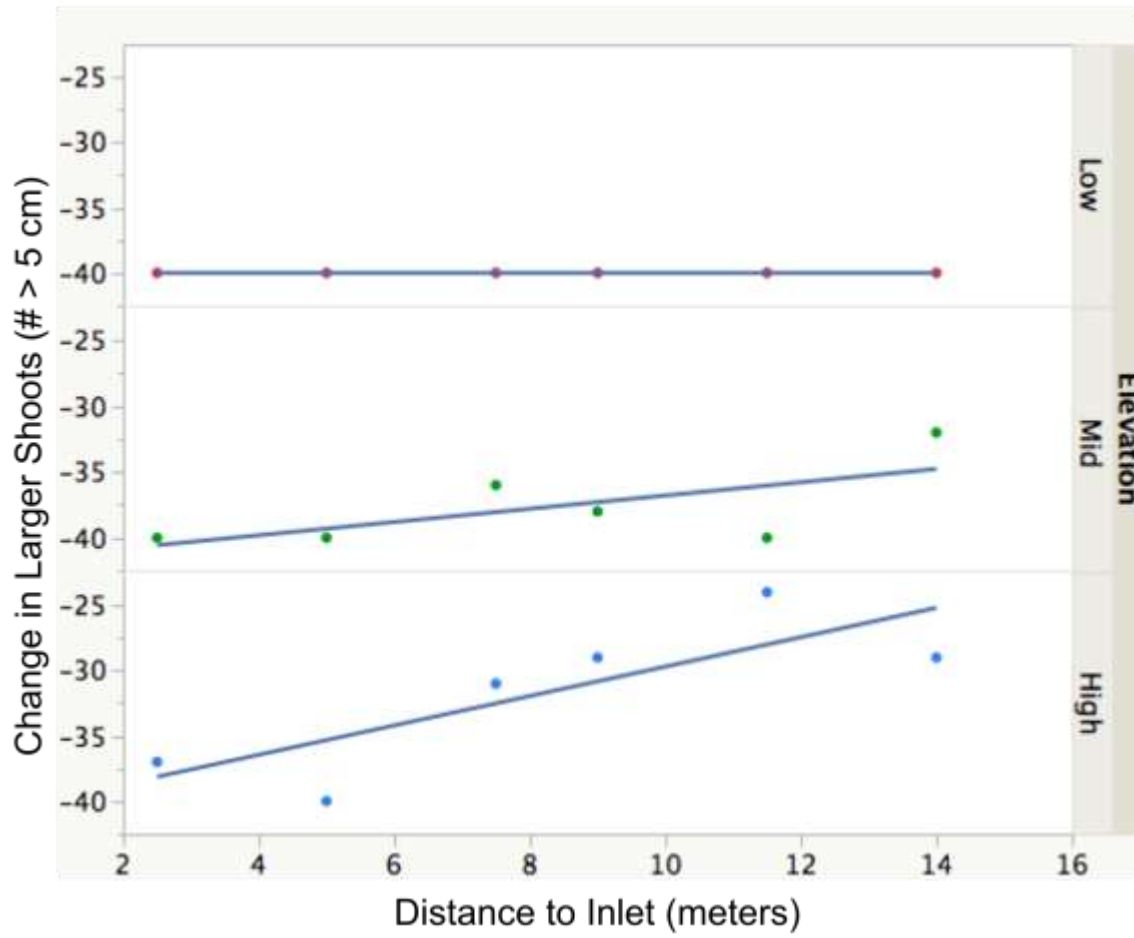
Figure 5. Pattern of loss of larger cordgrass shoots on the York River shoreline plantings relative to elevation and distance to the inlet under the Wiggley Bridge. Data are raw numbers for large shoots planted in each plot of 40 plants.

The shoreline was stabilized using baffles constructed from jute and wrack and then divided into 18 plots, with six plots at each of three elevations (high, mid and low). Smooth cordgrass was planted across the entire site and snails were removed weekly from half the plots and unmanipulated in the other half. By the end of the experiment, most of the taller shoots (greater than 5 cm) had been lost to snail grazing or physical breakage from currents or wave action, but most of the plantings put up many new young shoots. Figure 5 shows no survival of large shoots at the lowest elevation, but also very poor survival near the inlet. There was no effect of snails on these taller shoots, suggesting currents and waves contributed to their loss.

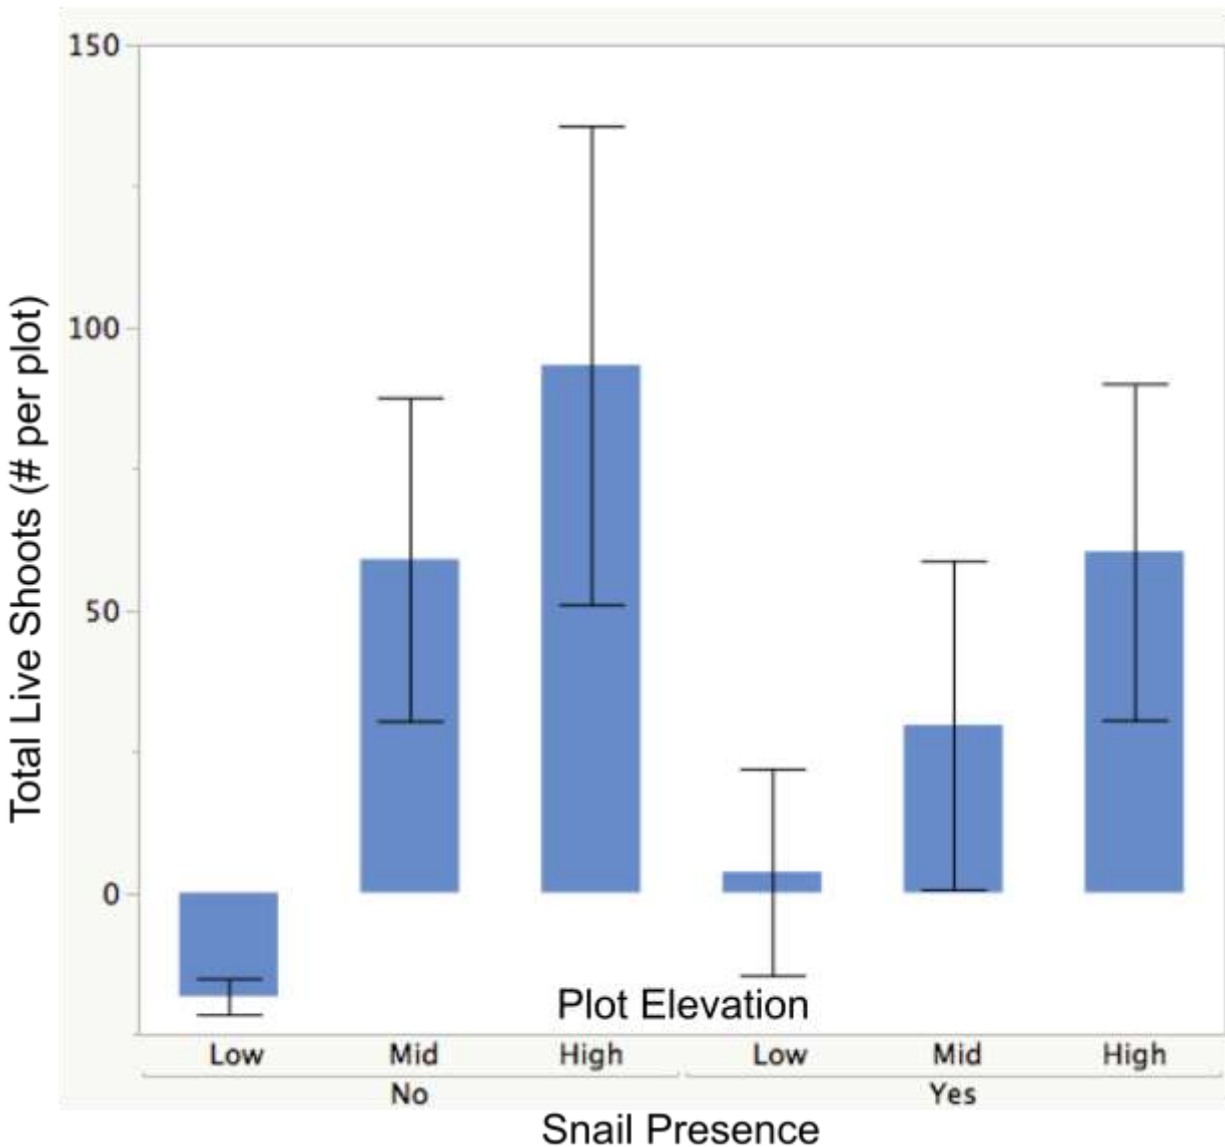
Figure 6. Total shoot number of cordgrass plantings averaged (with standard error bars) across three replicate plots of 40 planting units for each elevation and snail treatment on the York River shoreline.

Despite the loss of many of the larger shoots, most of the plants survived and produced new shoots that were still small by the close of the experiment. When tall and new short shoots are combined, there was a clear effect of elevation on their number, with mid and high elevation plots averaging many more shoots (Figure 6). Although the effect of snails was not statistically

significant at this site due to high variability (as indicated by large error bars), we found 60 to 90 shoots per plot if snails were removed but only 30 to 60 shoots in the presence of snails.

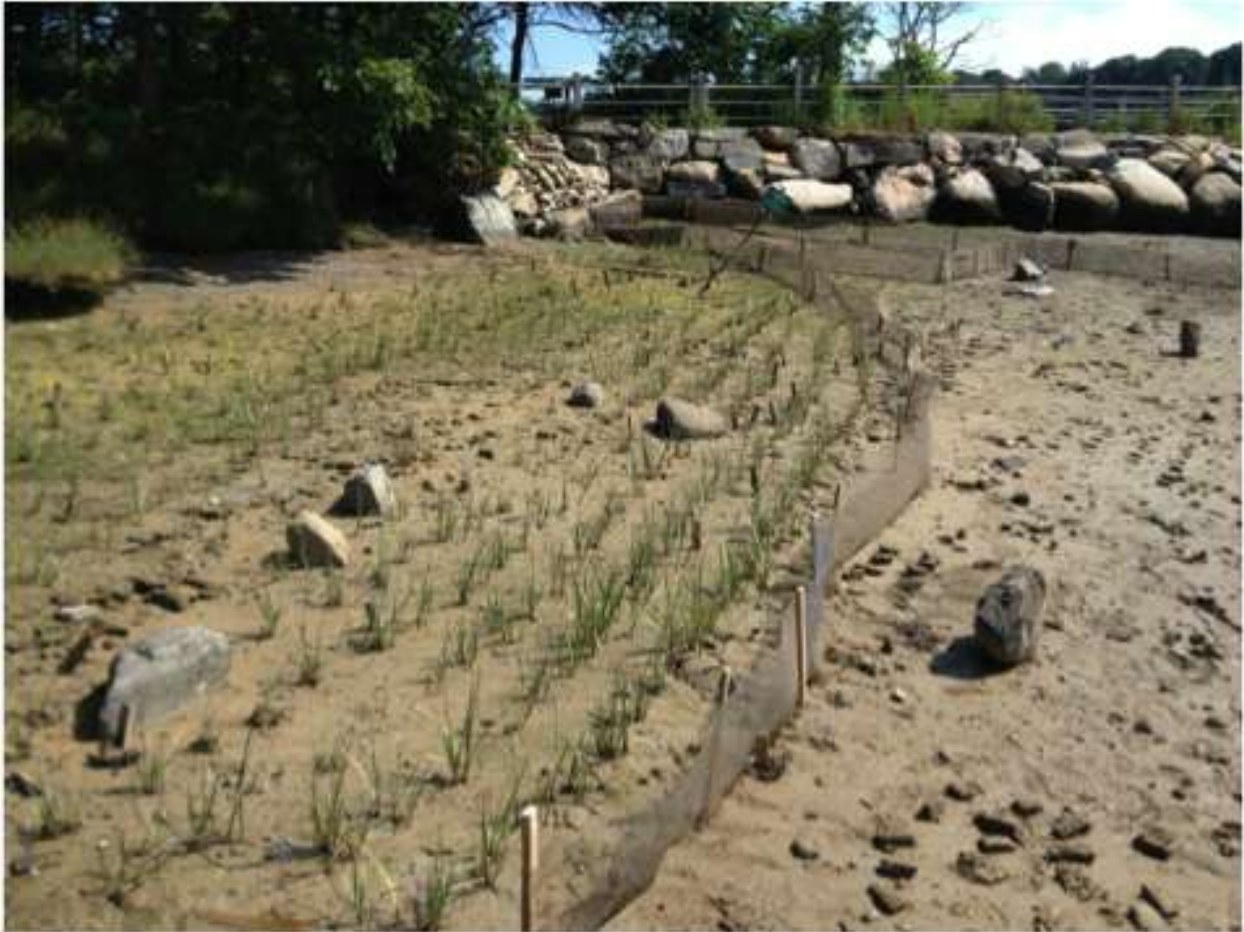
Figure 7. Restoration along the York River shoreline in July, 2017.

In Summer 2017 the plants were found to be growing well (Figure 7) and the site was cleaned of materials such as extra stakes and broken wire mesh. The wire mesh excluding snails was repaired and snails within the planted area were removed (580 on two occasions in July, 28 on one occasion in August). In August, the restoration site was evaluated for plant survival and proliferation of new shoots as well as 'volunteer' plants that seeded themselves. Survival of the planted cordgrass was estimated to be 92% at the close of the second growing season. The density of living plant plugs was about 28/m<sup>2</sup>. Thus plant density was almost twice as great as expected due to the expansion of plants. (We would expect to find 16/m<sup>2</sup> if all the plants survived but did not expand.) In addition, the number of shoots greater than 5 cm in height averaged 114 /m<sup>2</sup>. These results all indicate the restoration actions performed in 2016 (collection of fine sediments using jute baffles, fencing to exclude snails) are setting the conditions needed for marsh recovery at this site.

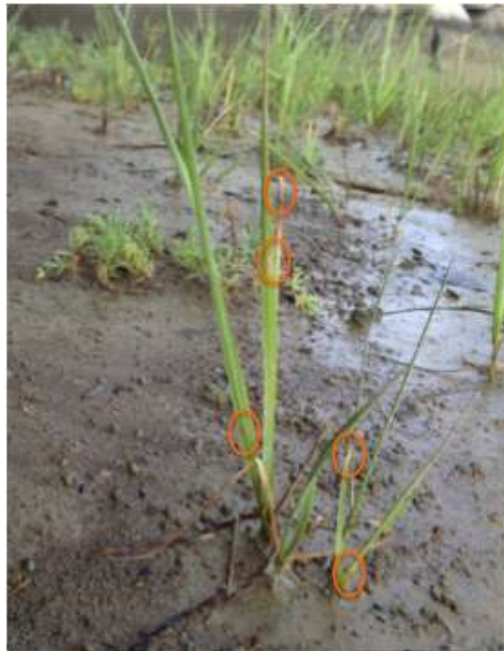
Figure 8. Snail damage to live portions of four shoots of one planting unit (not counting four dead leaves where source of loss is unknown). Damage is highlighted by five orange ovals.

When the survey was performed, only 28 common periwinkles were removed from within the restoration fencing. However most of the plants showed signs of snail damage such as broken shoots, broken leaves, torn leaves and grazed leaves (Figure 8). Snail damage was assessed carefully in only one of the plots. The fifth sample at the mid elevation had 27 live shoots within the frame, but 22 of those shoots had at least one leaf that appeared to be damaged by grazing.

Since most of these damaged shoots have only 2-4 leaves, our observations suggest snail damage has significant impacts that weaken plants through the growing season.

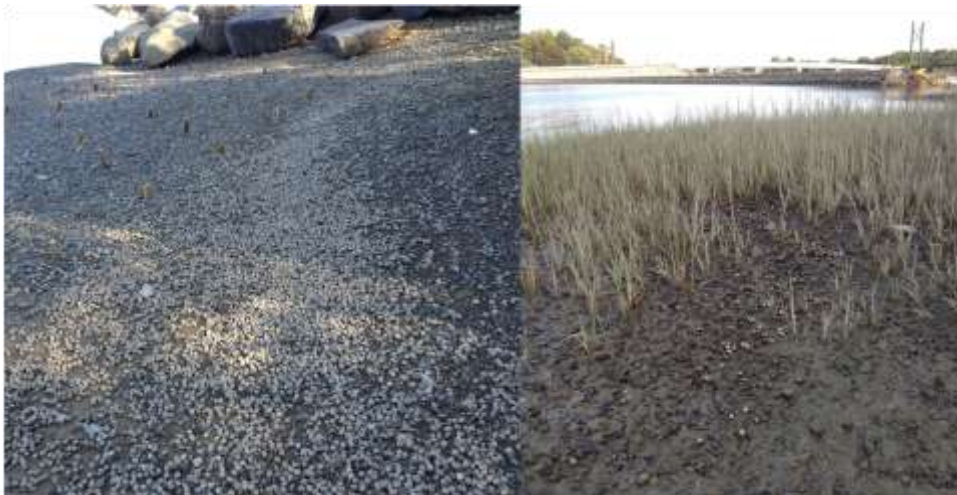
Figure 9. Large dense (left) and small diffuse (right) waves of common periwinkles on the Barrell Pond shoreline.

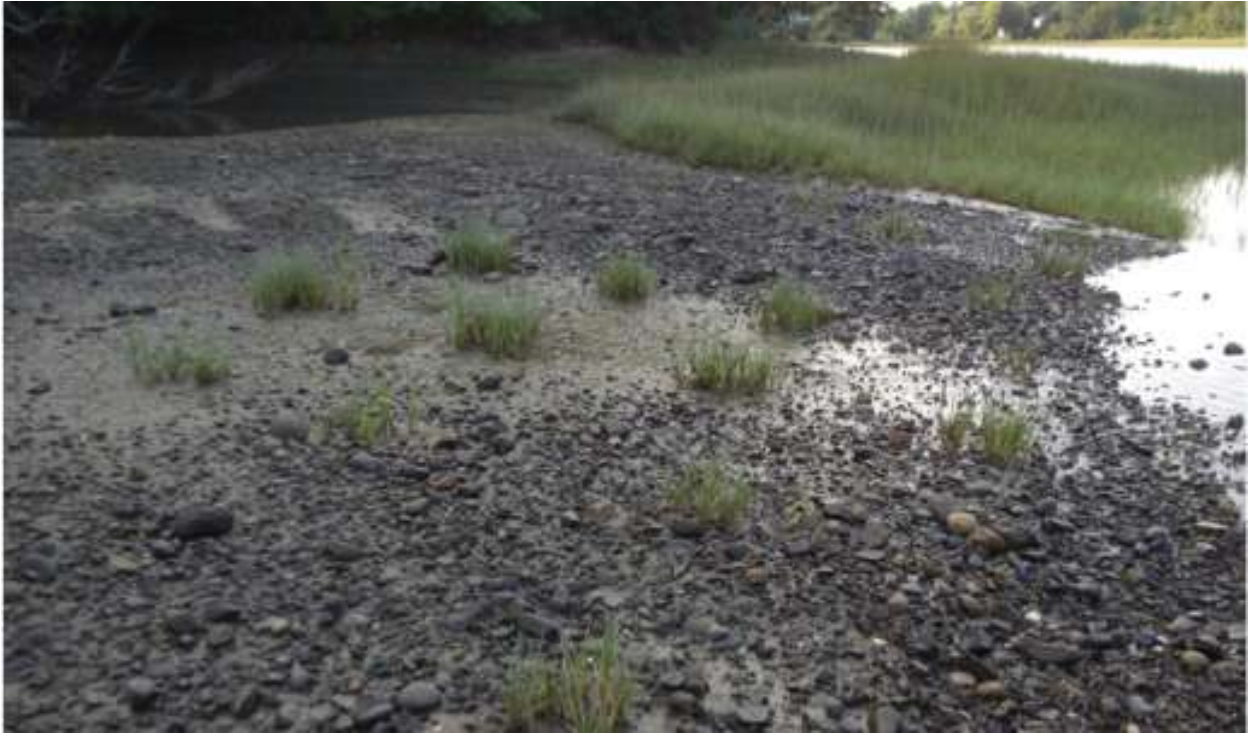
Figure 10. Cordgrass plants in 2017 from the plants caged in 2015 in the Barrell Pond.
